Assembly Group Report

Patrick Lukens
Fermilab

Detector Assembly

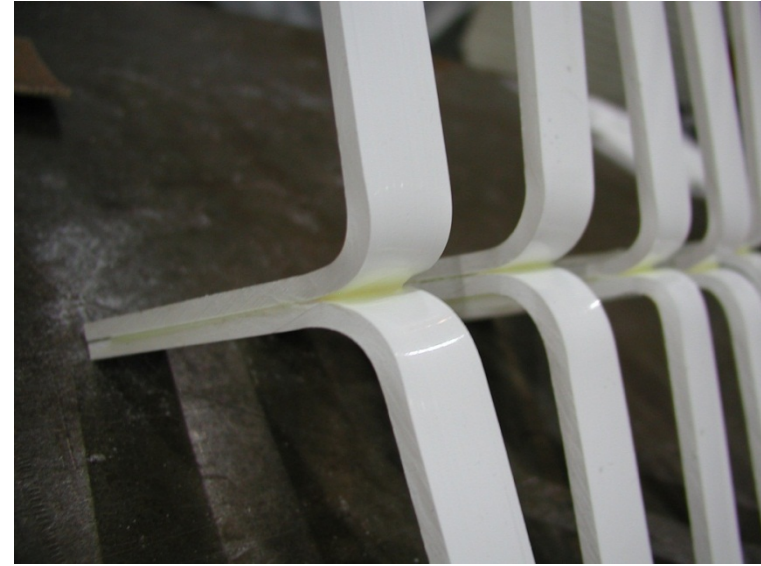
Peel samples
100 pounds/inch seen

- Safety factor in shear is ~ 8 , ~ 10 or more in peel.
- All glued surfaces will be scuffed with sandpaper
 - Considered to be very conservative, since stress declines with height.

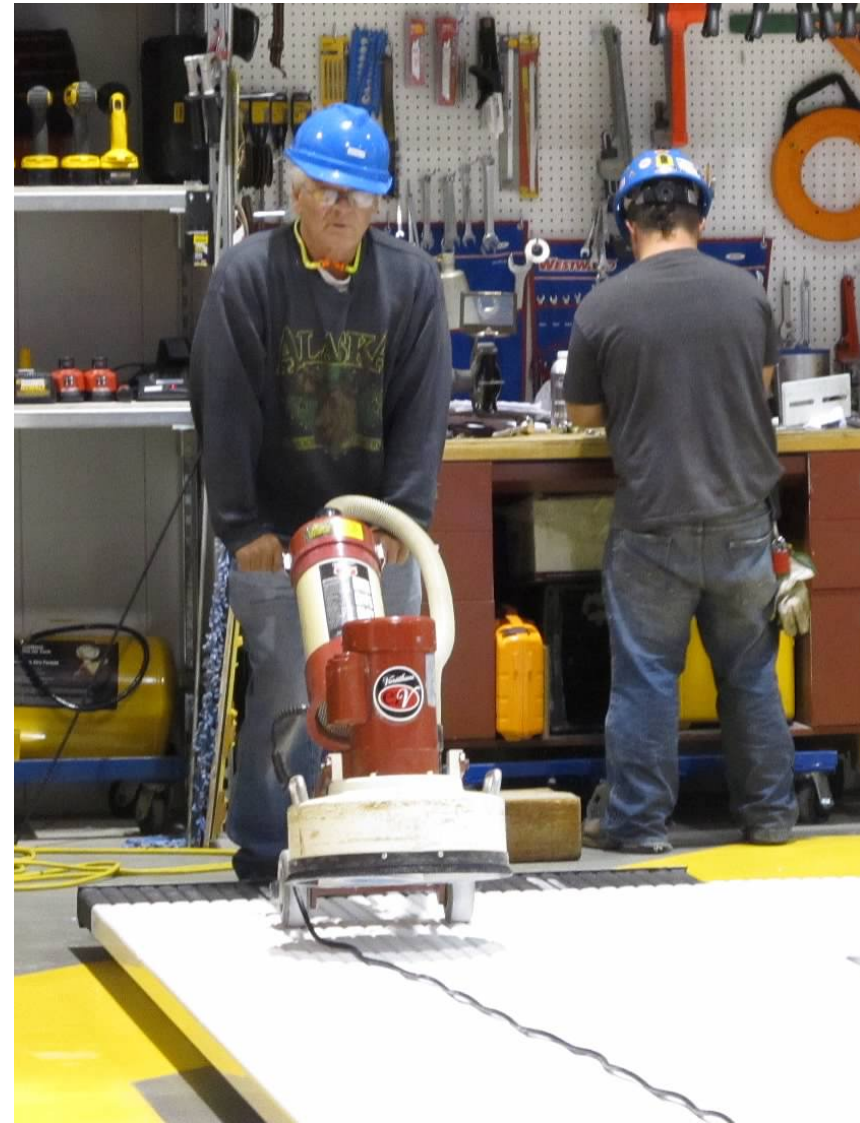
- Blocks are built with scuffing for all glued surfaces.
- For first 6 layers, leak and optical fiber tests were repeated after scuffing
 - No failures were found
- Current technique is a floor sander, 80 grit sandpaper.
- Probably ~40 minutes per module
 - Requires crane to move, people to flip, space to work
 - Not compatible with the Ash River assembly schedule.
- This work will be done in Minneapolis in the future.

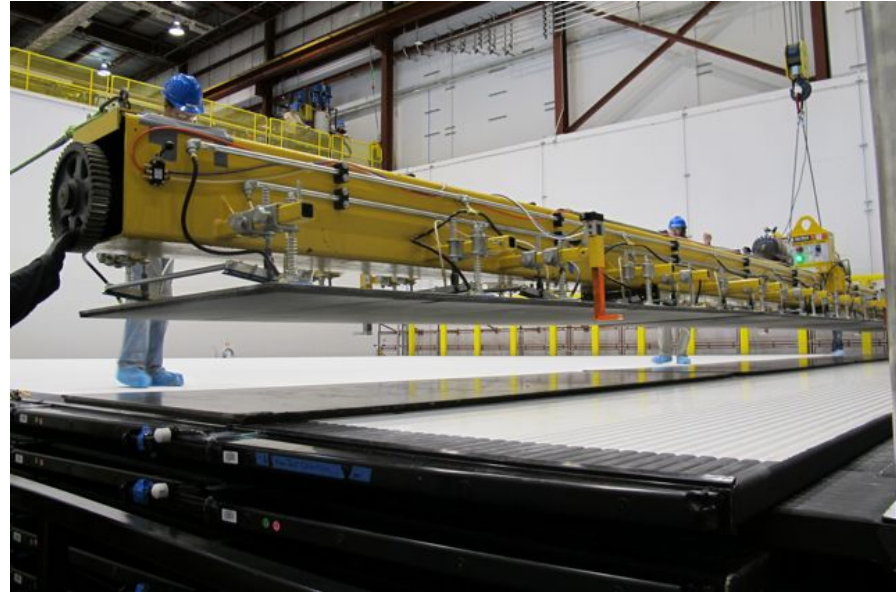
Compression plates for last
module of Block 0

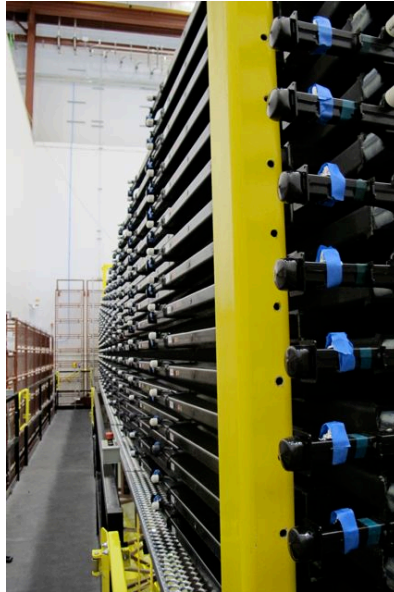
Edge view of
Block 0

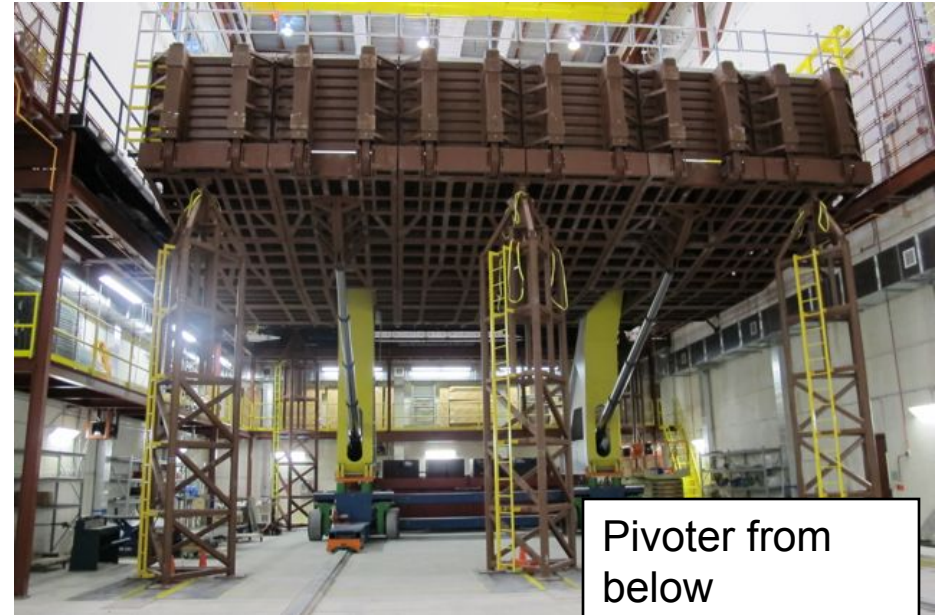
Pivoter from
below

- The completed block contains 384 modules, 200 tons
- The assembly table, the Block Pivoter drives the block 300 feet to the south, then positions it against the wall or previous block.

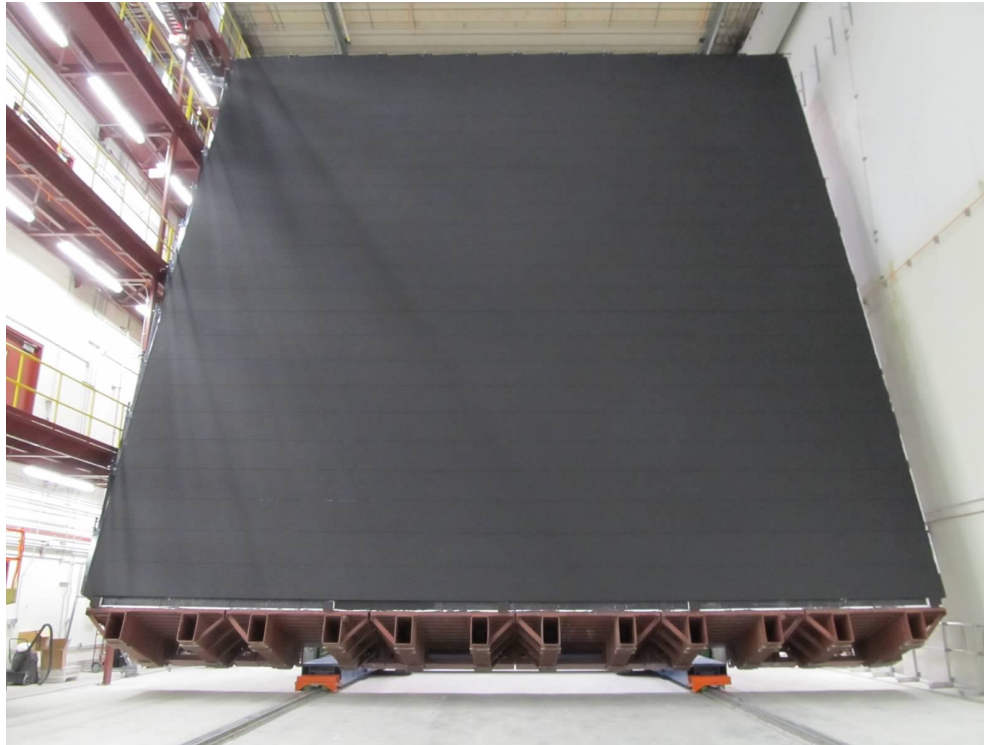
Block Installation

- Block 0 went in on 10 Sep.
 - Slowed, due to the drive being set for too low an operating pressure
 - A few components were changed, controls reprogrammed for the second block
